# Manhole Inspection Summary

Manhole # S19E\_\_013MH

Insp Date: **10/10/07 1:56 PM**

**Location** Address: **1947 PENROSE-LEXINGTON**

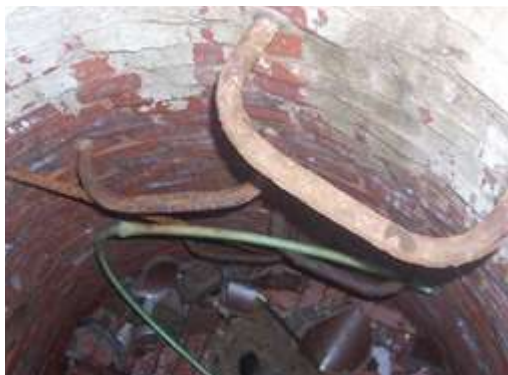
Defect 6

**Steps** Count: **4** Missing: **0** ☒ **Corroded**

CORRODED STEPS

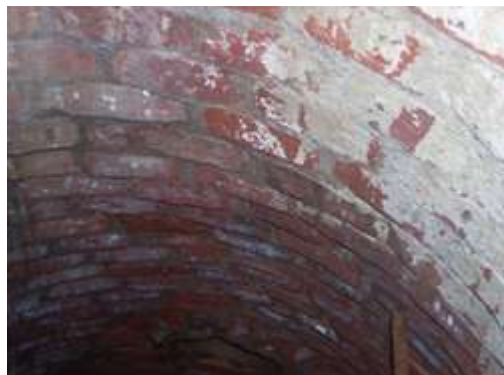
Defect 5

Infiltration: ☐ None ☐ Joint ☐ Cracks ☐ Mortar ☐ Roots ☒ **Wall**

INFILTRATION OF THE CORBEL WALL

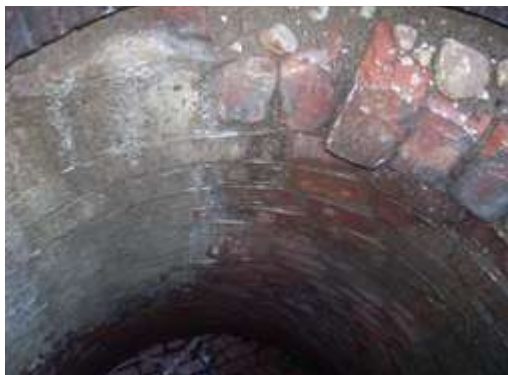
Defect 4

Infiltration: ☐ None ☒ **Joint** ☐ Cracks ☐ Mortar ☐ Roots ☒ **Wall**

INFILTRATION OF CHIMNEY WALL

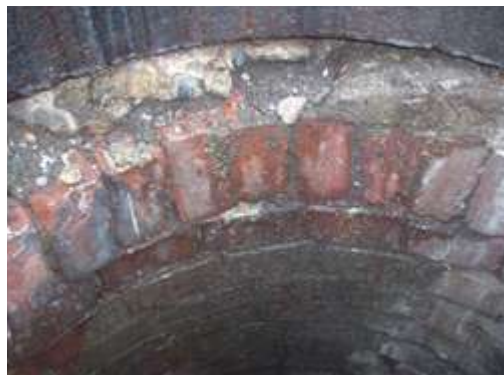
Defect 3

INFILTRATION OF JOINT

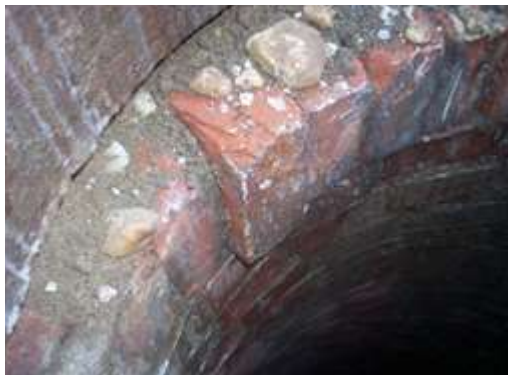
Defect 2

Condition: ☐ Sound ☐ Cracked ☐ Root Intrusion ☒ **Loose Brick** ☒ **Deteriorated**

LOOSE CHIMNEY BRICKS

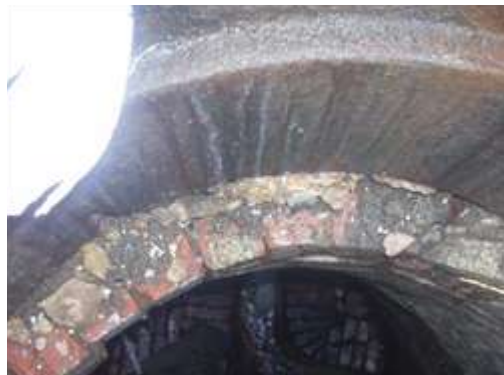
Defect 1

**Frame** Offset: **4** (in.) Condition: ☒ Sound ☐ Cracked ☐ Leaks

FRAME OFFSET

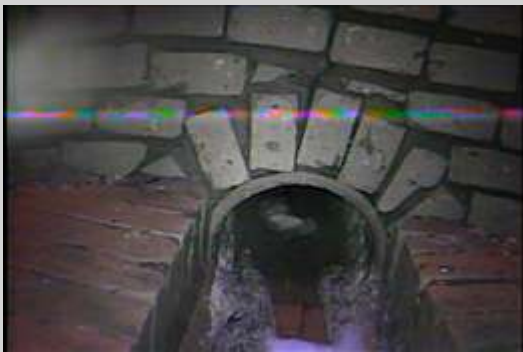
12 O'Clock Outflow

Pipe Height: **8.4** (in.) Rod and Bar (Angled)  
Pipe Material: **Clay** ☐ Pipe Lined  
Invert Depth: **8.32** (ft.) Flow Characteristics: **Slow**  
Deposits: ☐ None ☐ Mud ☐ Sludge ☐ Debris ☒ Grease  
Silt Depth: **1** (in.) Deposits Extent: **Light**  
Infiltration: **None** Pipe Seal Cond: **Sound**

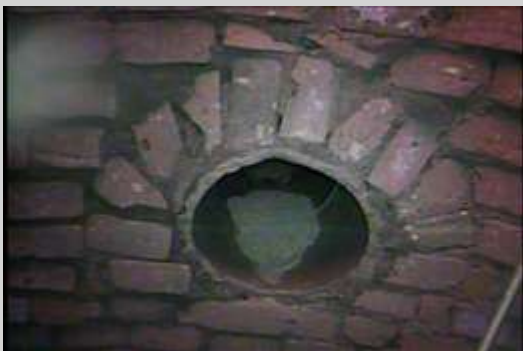
3 O'Clock Inflow

INFILTRATION OF THE CORBEL WALL

Pipe Height: **8.4** (in.) Rod and Bar (Angled)  
Pipe Material: **Clay** ☐ Pipe Lined  
Invert Depth: **6.17** (ft.) Flow Characteristics: **Slow**  
Deposits: ☒ None ☐ Mud ☐ Sludge ☐ Debris ☐ Grease  
Silt Depth: (in.) Deposits Extent:  
Infiltration: **None** Pipe Seal Cond: **Sound**

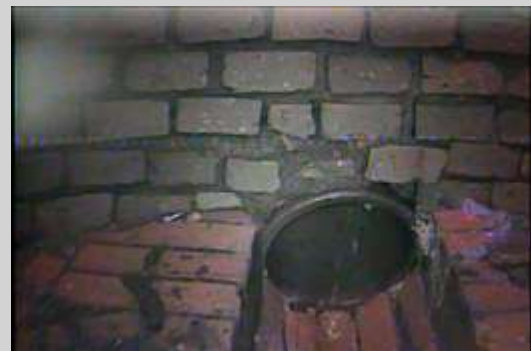
Drop In @ 3 O'Clock

INFILTRATION OF THE CORBEL WALL

Drop: **Outside** Rod and Bar  
Angled: **Yes** Reading: **7.14** (ft.)  
Inv Depth: **8.14** (ft.)  
Drop Condition: **Open**
